Chapel of St Michael Rycote, Oxfordshire

Archaeological Watching Brief Report

OXFORD ARCHAEOLOGICAL UNIT

March 1995

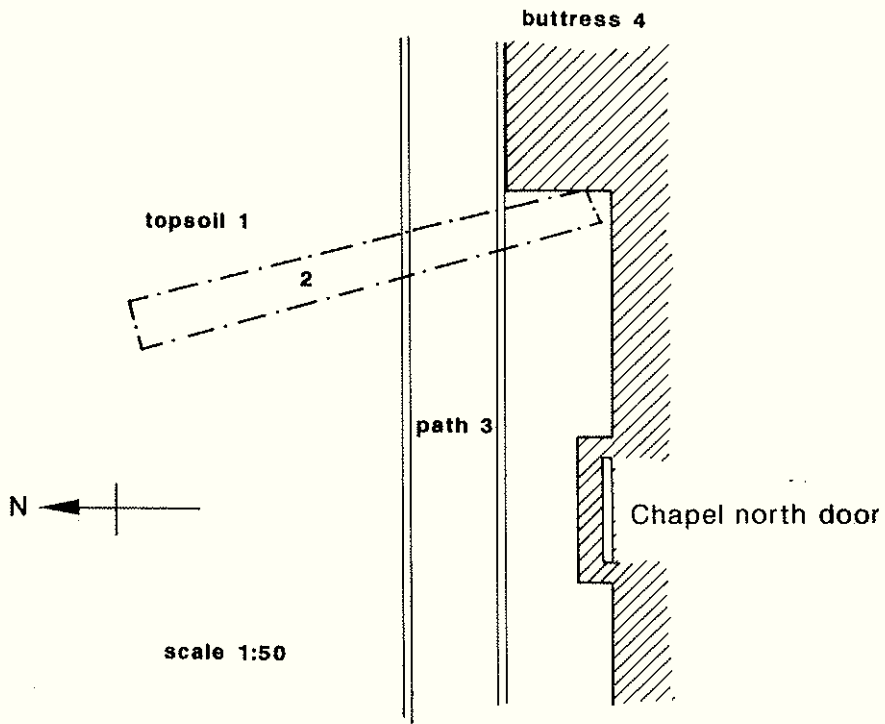
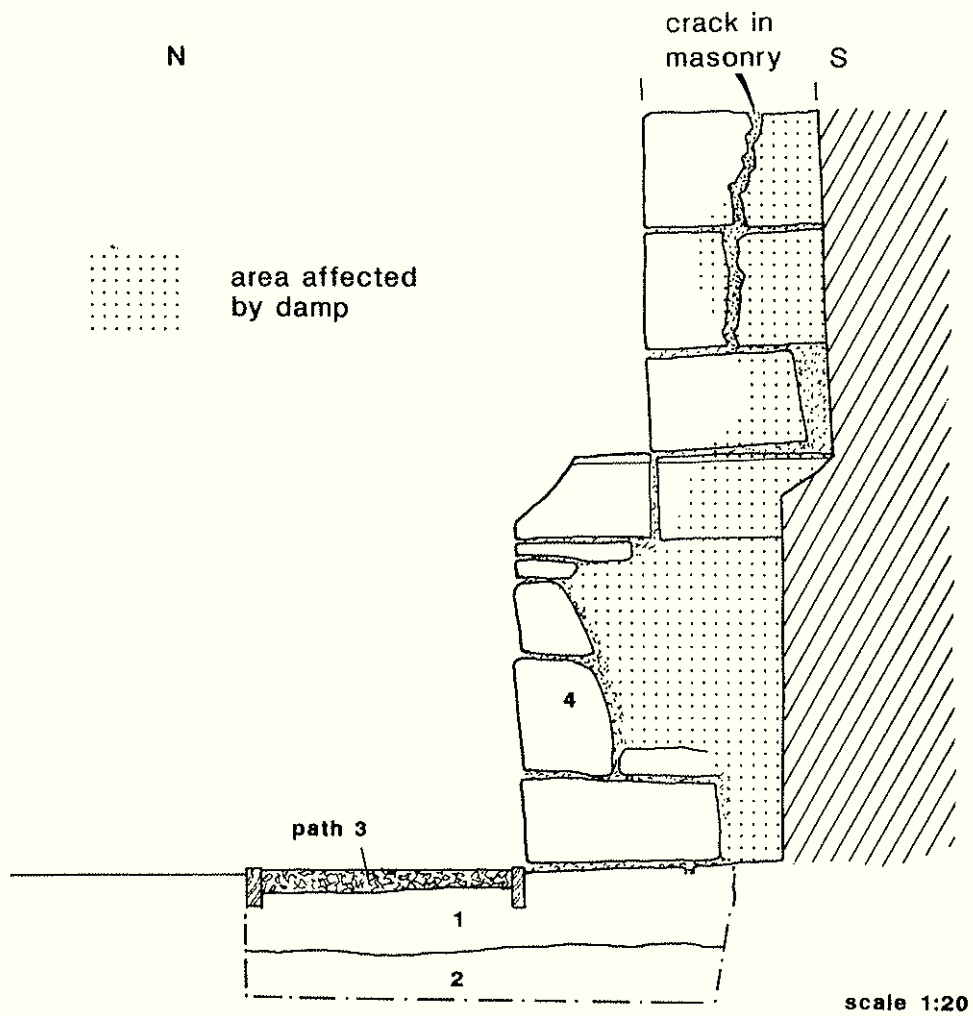
figure 2

The excavated drainage trench [Fig. 2] was 3m long, 0.25 m wide and c. 0.30 m deep. The trench ran from a buttress in the N wall of the chapel [c. 1.60 m from the N door] into the chapel grounds. The trench was aligned NW-SE. The earliest deposit [2] found at the base of the trench was a mixed layer of sand and loam containing fragments grey shelly limestone roofing tile. This layer butted the wall [and buttress 4] of the chapel, and was sealed by the topsoil. Topsoil [1] was a dark brown clay loam, containing red tile fragments, and was 0.22 m thick.

The effects of the damp on the chapel were apparent. In addition to several patches of moss on the walls, all of the buttresses show signs of decay [see Fig. 2]. Substantial cracks in the buttresses were observed: some of the cracks continued to ground level.

trench plan and section detail
